HAZARDOUS MATERIALS SPECIAL INVESTIGATION REPORT

**COLLISION BETWEEN
A TRACTOR-SEMITRAILER
TRANSPORTING BOMBS AND
AN AUTOMOBILE,
RESULTING IN FIRE AND EXPLOSIONS
CHECOTAH, OKLAHOMA
AUGUST 4, 1985**

NTSB/SIR-87/01

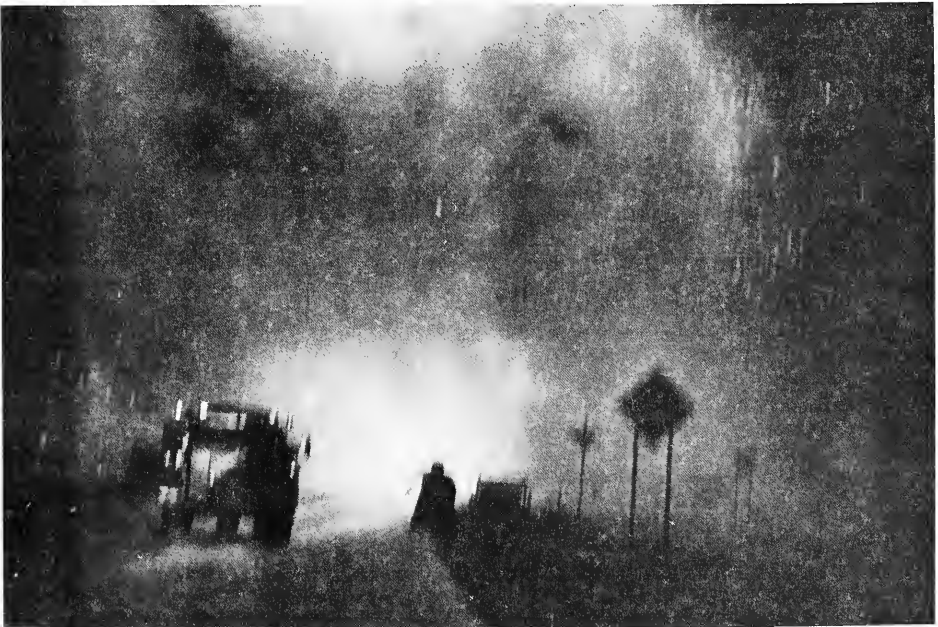
About 3:45 a.m., the fire trucks were preparing to withdraw from the I-40 accident site when an explosion occurred. The fire chief said that he saw the mushroom effect of a bomb explosion and flying shrapnel and debris. He said that the explosion occurred near the front of the semitrailer and that, based on his military training, he was certain (after the incident) that a bomb had exploded. He described the explosion as "seeing a 104 or 105 Howitzer 1/ round go off, a bunch of Roman candles on the outside of it, and no flames." (See figure 1.)

Figure 1.--Fire chief's truck in foreground of explosion.

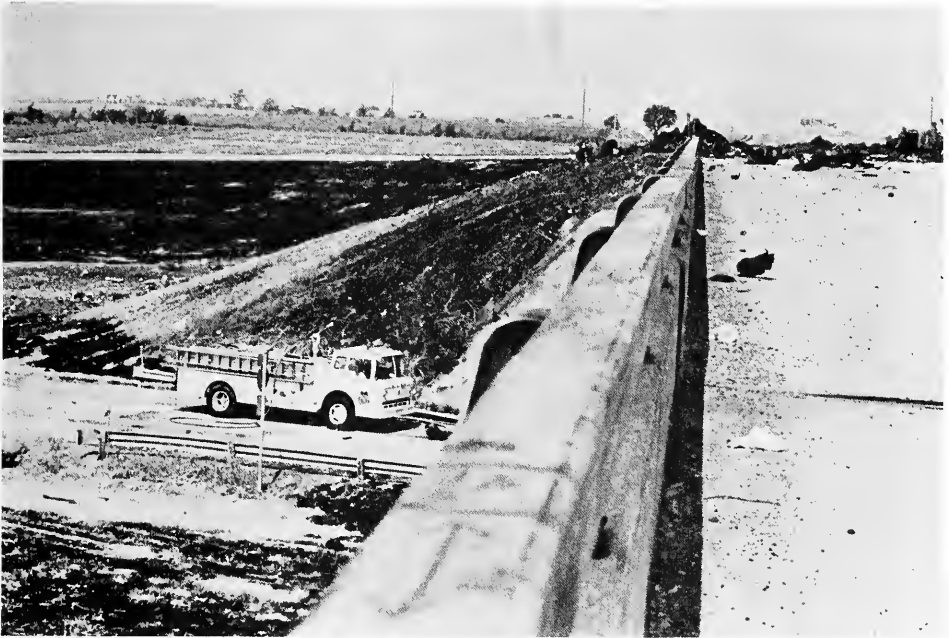
Figure 2.—Fire truck parked on "old" U.S. 69 about 150 feet east and 26 feet below the resting position of the semitrailer before the explosions. (Photograph courtesy of the State of Oklahoma Department of Transportation.)

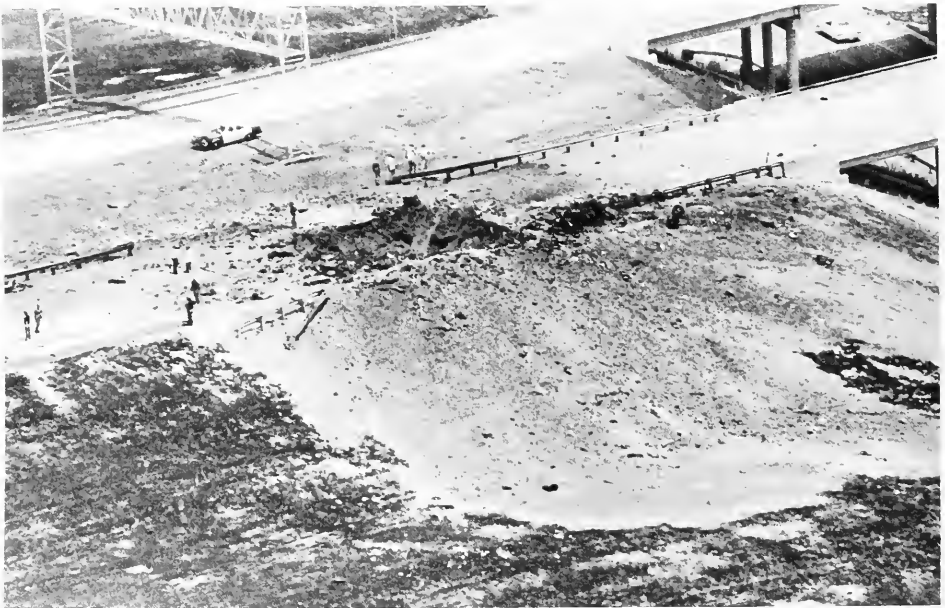
Figure 3.—Accident site.
(Photograph courtesy of the State of Oklahoma Department of Transportation.)

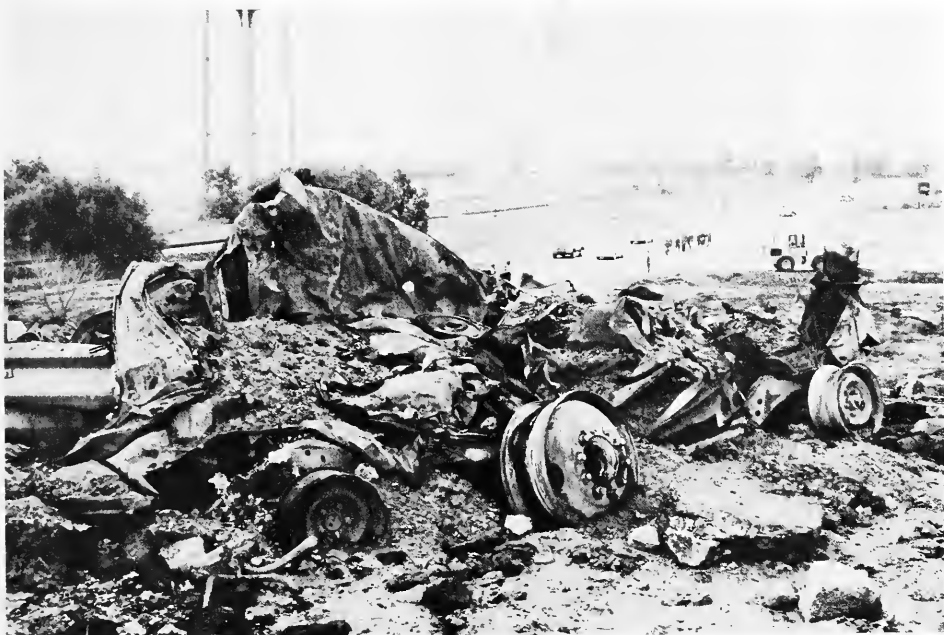
Vehicles.—The tractor-semitrailer and automobile were destroyed by fire and explosions after the accident. (See figure 5.) Examination of the wreckage disclosed that the automobile had sustained moderate impact damage to the left rear section. The rear

Figure 5.—Tractor-semitrailer and automobile wreckage after explosions and fire.

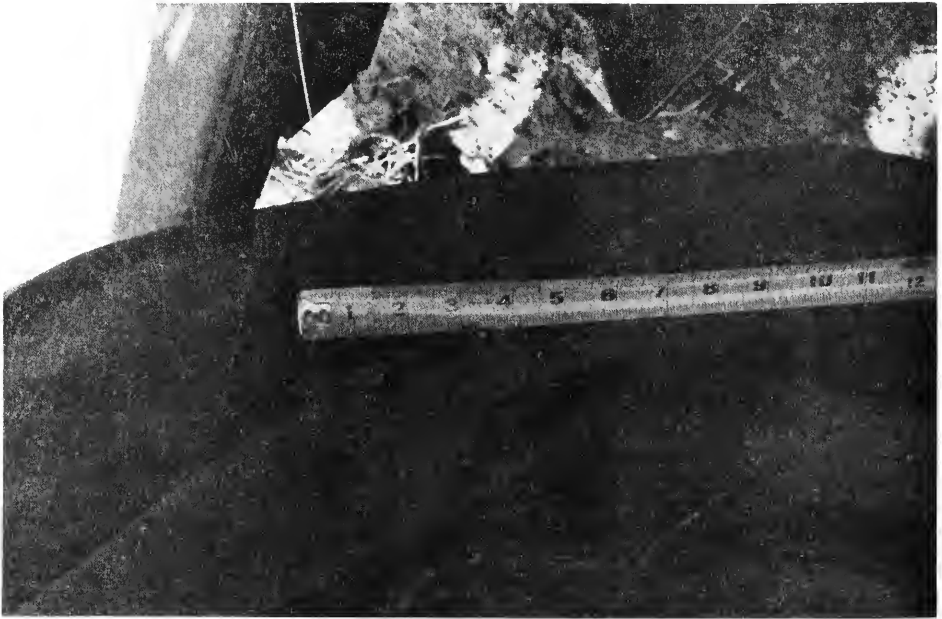
bumper was pushed forward about 18 inches and downward into the 26-gallon capacity fuel tank. ^{2/} This penetration was about 56 inches to the left of the right edge of the bumper. A 5-inch split was found in the fuel tank adjacent to the area of maximum penetration by the rear bumper. (See figure 6.) The left frame rail was bent 23 inches downward from its point of attachment near the left rear shock absorber. It was crimped 32 inches forward of its attachment to the bumper.

Figure 6.—Automobile fuel tank.

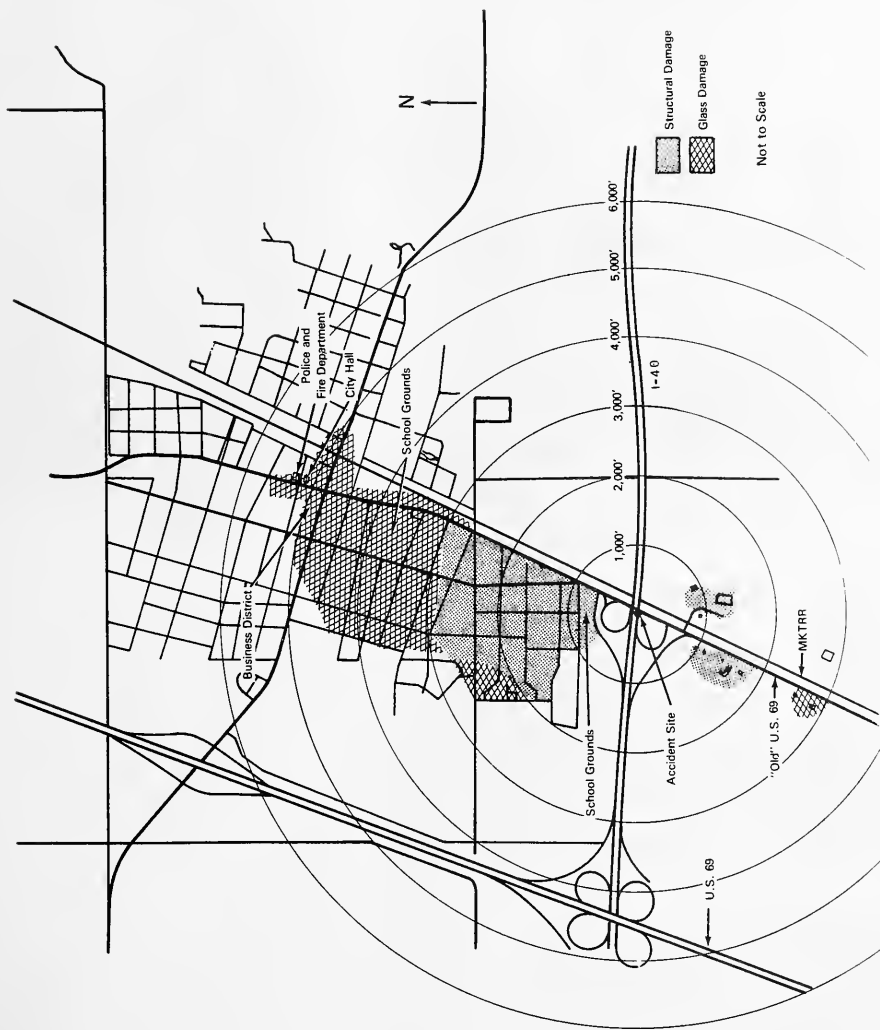
Other.—The concussion (overpressure) and flying debris from the explosions caused substantial damage to many structures in the Checotah area. Buildings nearest to and north of the accident site generally sustained the most severe damage. (See figure 7.) The explosions shattered windows, damaged roof trusses and door frames, collapsed ceilings and light fixtures, and weakened interior and exterior walls. Total property damage was estimated at \$5 million. ^{3/}

Figure 7.—Diagram of concentrated areas of structural and glass damage to buildings, Checotah, Oklahoma.

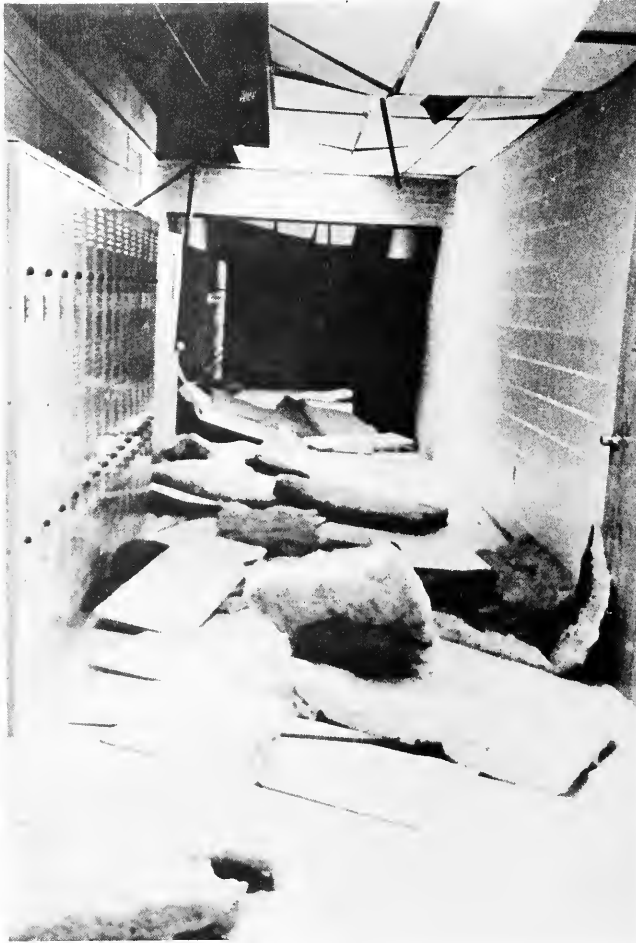
Several school buildings, a manufacturing plant, and two gasoline stations also incurred substantial damage. Damages to the Checotah Middle School, located about 734 feet north of the accident site were estimated at \$215,000. Damage to other school buildings was estimated to be \$85,000. (See figure 8.) Damage to commercial structures was estimated to be \$225,000. About 60 percent of the plate glass windows in downtown Checotah (about 1 mile from the accident site) were shattered. (See figure 9.)

Figure 8.—Damage at Checotah school
located near accident site.

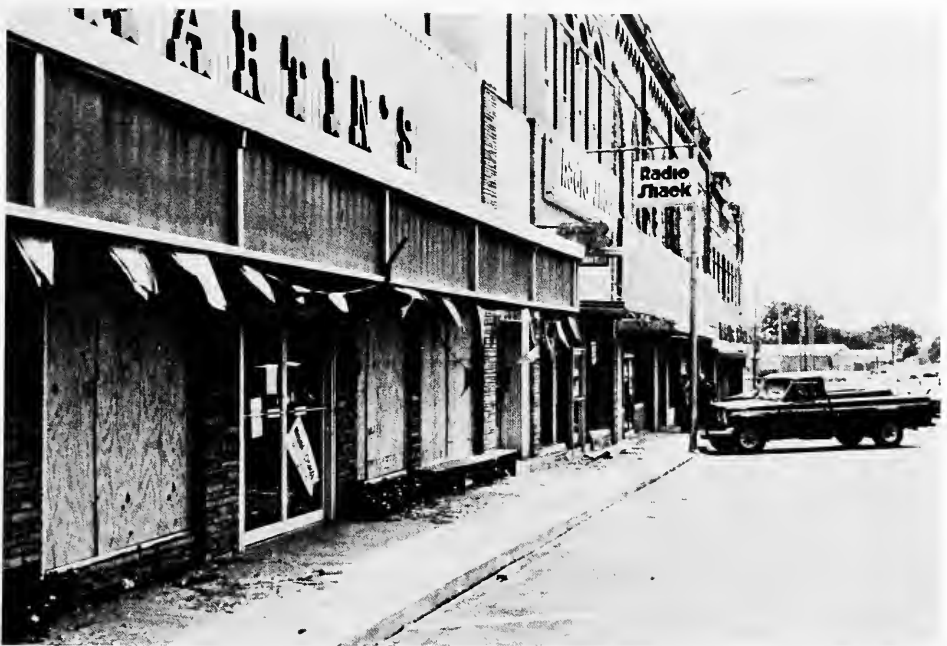
Figure 9.—Checotah central business district located about 1 mile from the accident site.

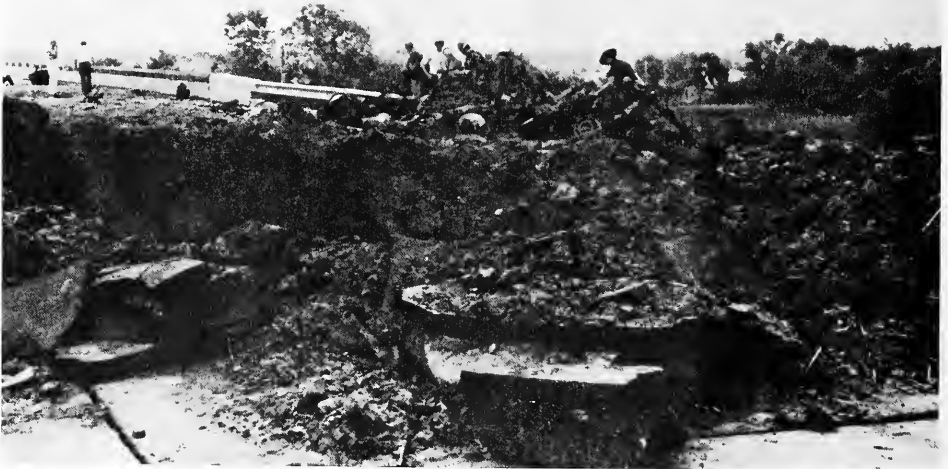
The explosions also destroyed a Checotah fire truck, two eastbound lanes of I-40, a merge lane from the "old" U.S. 69 entrance ramp, the right shoulder of the highway, several feet of guardrail, and numerous highway signs. (See figure 10.) Approximately 3,382 tons (1,700 cubic yards) of material were used to fill the crater left by the explosions. The Oklahoma Department of Transportation reported repair costs to be about \$85,000.

Figure 10.—Damaged I-40 eastbound lanes at accident site.

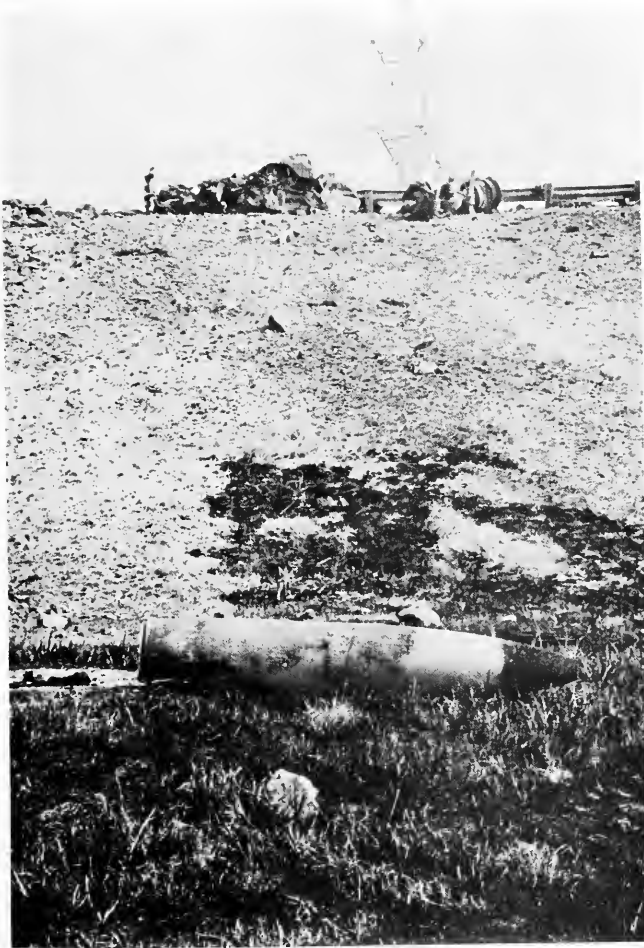
Figure 11.—MK 84 general purpose bomb at accident site.
(Photograph courtesy of the State of Oklahoma Department of Transportation.)
